THE RELATION OF LOW TEMPERATURE
DEFORMATION AND SUSCEPTIBILITY TO HYDROGEN
EMBRITTLEMENT OF AUSTENITIC STAINLESS STEELS

Peter Francis Scardigno

THESIS

December 1974

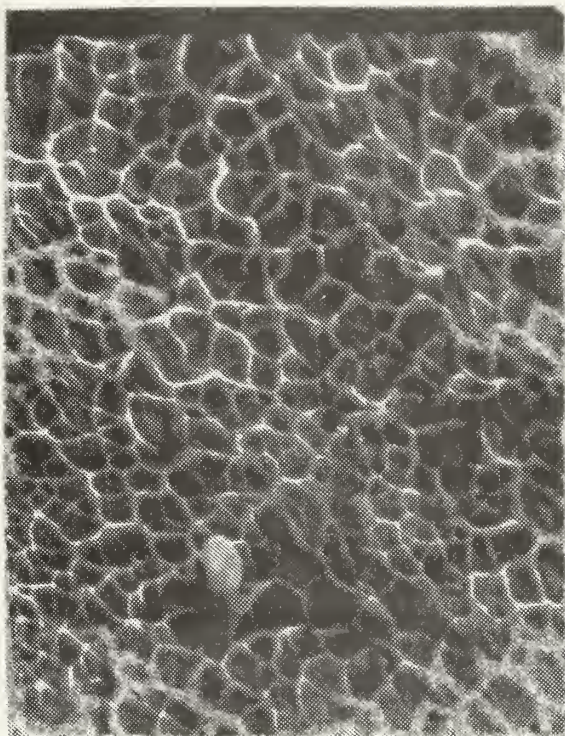
SEM FRACTOGRAPH 10

FIGURE 46. 21-6-9, 300°K, UNNOTCHED, 33.75%
ELONGATION PRIOR TO CHARGE

2300X

Minor elongation of uniform dimples. Pebbling predominates the substructure of the dimples.

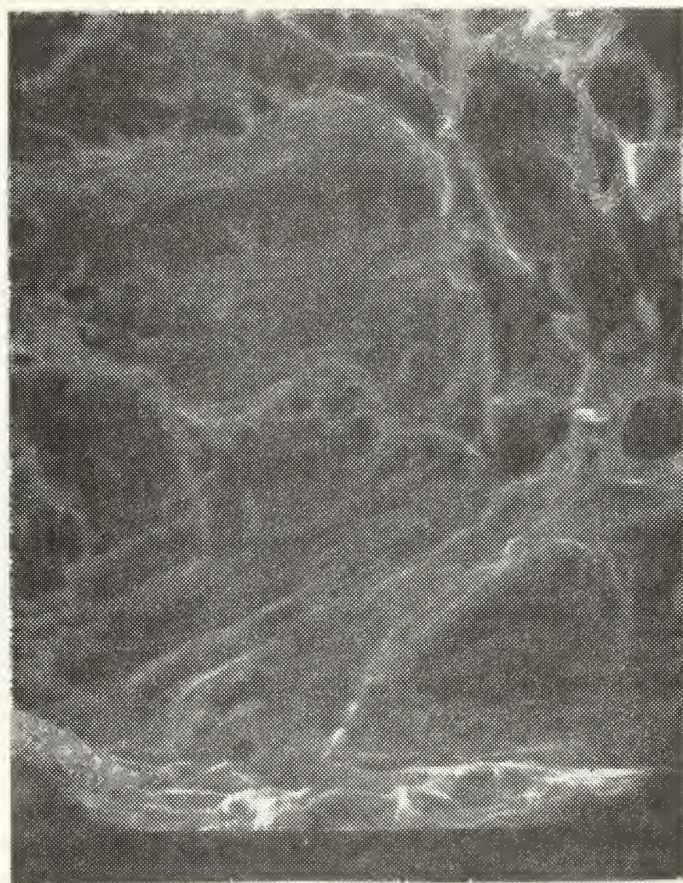
SEM FRACTOGRAPH 37

FIGURE 60. 21-6-9, 195°K, NOTCHED, 0%
ELONGATION PRIOR TO CHARGE

2300X

Extremely corrugated appearance with minor dimpling. Probably a form of quasi-cleavage. Slight microvoid formation with tearing and stretching indicated.

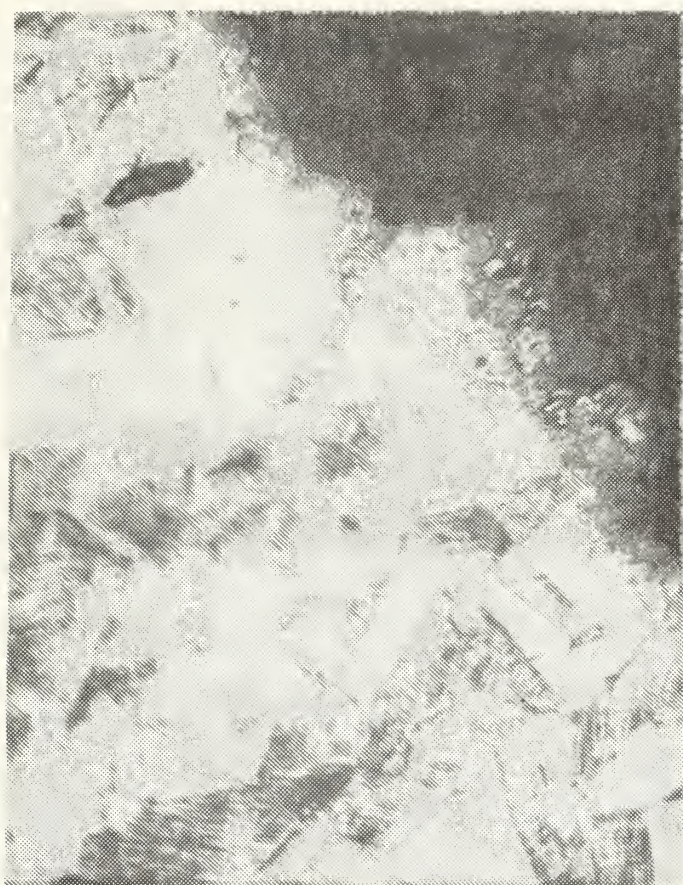
FIGURE 69. METALLOGRAPHIC PHOTO, 21-6-9,
76°K, NOTCHED GEOMETRY

Selected notched samples of 304-L and 21-6-9 were mounted, polished and etched to determine if any martensitic structure had formed. Because of the variation in composition of these two stainless steels two separate etchants had to be utilized. 21-6-9 required five grams of ferric chloride, 50 ml. of hydrochloric acid and 100 ml. of water. 304-L's etchant consisted of five ml. of nitric acid, one ml. of hydrofluoric acid and 44 ml. of water. Figures 68 and 69 are the result of this study.

The metallographic analysis of 21-6-9 indicated that no martensitic structure occurred by deformation and/or by temperature activation. Slip lines are evident throughout the grains of this specimen in a uniform manner.
